High beam current operation with beam diagnostics at LIPAc

9-13 Oct. 2023
HB2023@CERN, Switzerland

Linear IFMIF Prototype Accelerator (LIPAc)

Paper ID: FRC112

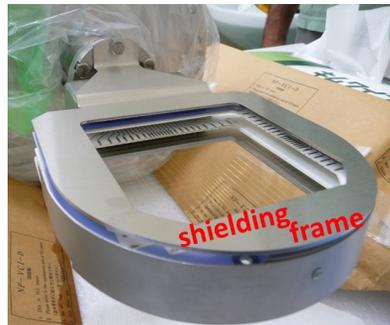
- Fine wire density on center
- Gaps between wires
 - D-Plate one: 1 / 2 / 3 mm
 - HEBT one: 2 / 2.5 / 3 / 4.5 mm

Due to the large wire gaps in the extreme, it cannot be possible to use a normal technique of an emittance measurement (slit + SEM-grid). The steerer has been installed.

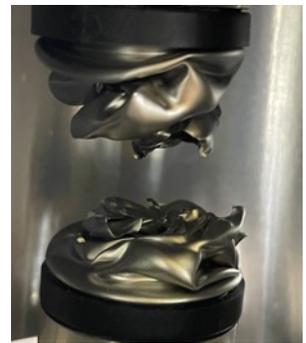
everyday is not a good day... motor coupling of one DSL damaged without anyone knowing → noticed at annual maintenance

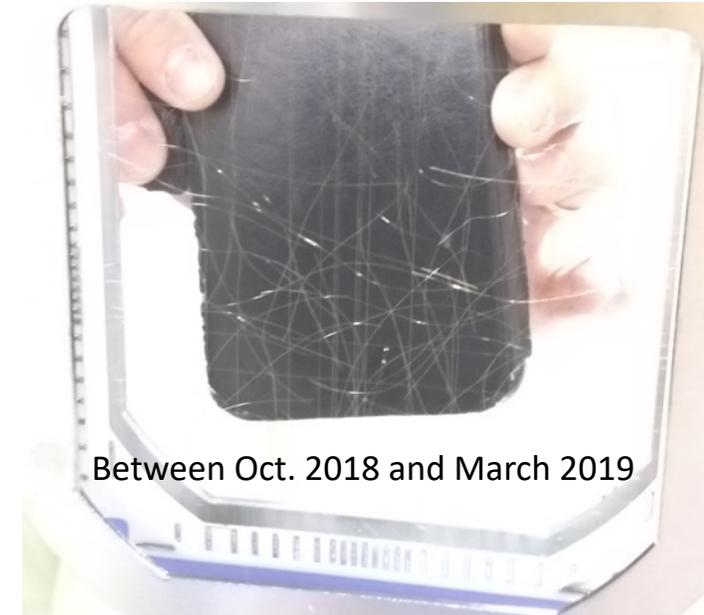
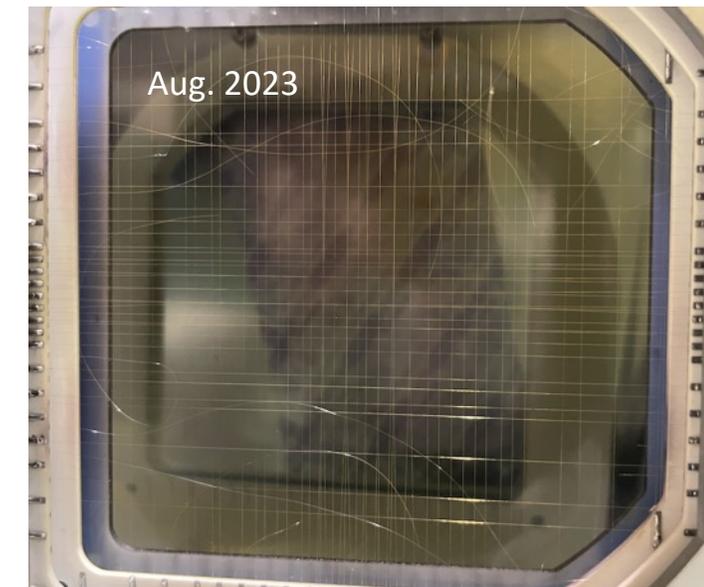
sensitive to the vacuum related,

- (1) Vacuum chamber shared with 2 horizontal ionic pumps -> some arcs were in the chamber, it destroyed the DAQ.
- (2) Sudden "big" vacuum changed by the system error, and/or human error, wires damaged two times even there's no beam operation.

→ Maintenance procedure updated to avoid the failure

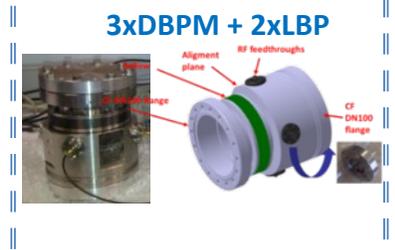
14x BPMs (for Phase B+)

BPM	Quantity	Range	Accuracy	Resolution
MEBT	Position	0 to 5 mm	0.1 mm	0.01 mm
	Mean Energy	5MeV ± 10%	0.05MeV	0.05MeV
Cryomodule	Position	0 to 5mm	0.25 mm	0.025mm
	Phase		2 deg	0.3deg
D-plate, HEFT	Position	0 to 5 mm	0.3 mm	0.01 mm
	Mean Energy	4 to 10 MeV	0.05 MeV	0.05 MeV

Devoting to measure transverse centroid position/phase/energy
