Muon Production Target at J-PARC

Shiro Matoba KEK J-PARC

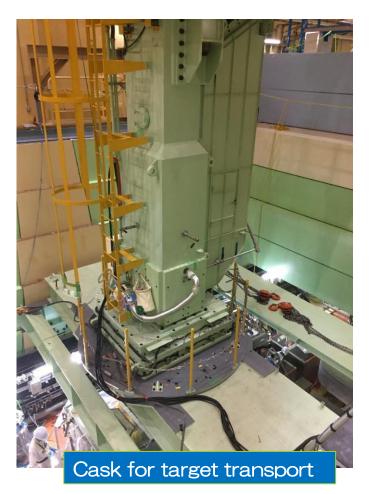
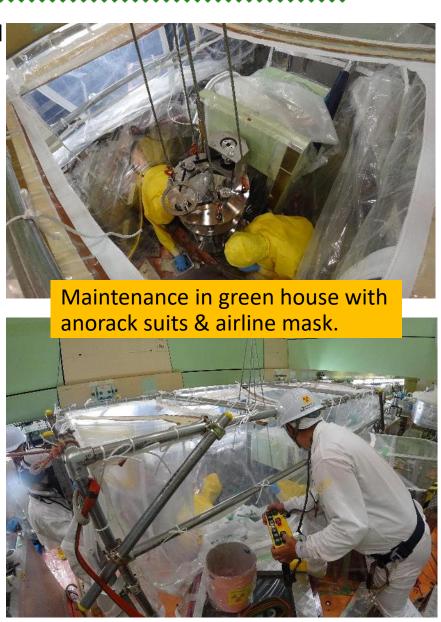
Replacement work

- Rotating target (No.1) was successfully pulled out from proton beamline.
- Tritium contamination level (Max: 0.3 Bq/cc) was lower than the J-PARC regulation value (0.8 Bq/cc).
